Service Bulletin

4-STROKE
BULLETIN GS/GSX/GSX-R NO. 199
DATE: 4/6/2009

SUBJECT: ABNORMAL CLUTCH NOISE

AFFECTED UNITS: ALL GSX1300RK8, ALL GSX1300BKK8, AND
CERTAIN GSX1300RK9 MODELS (See Affected Units on Page 2)

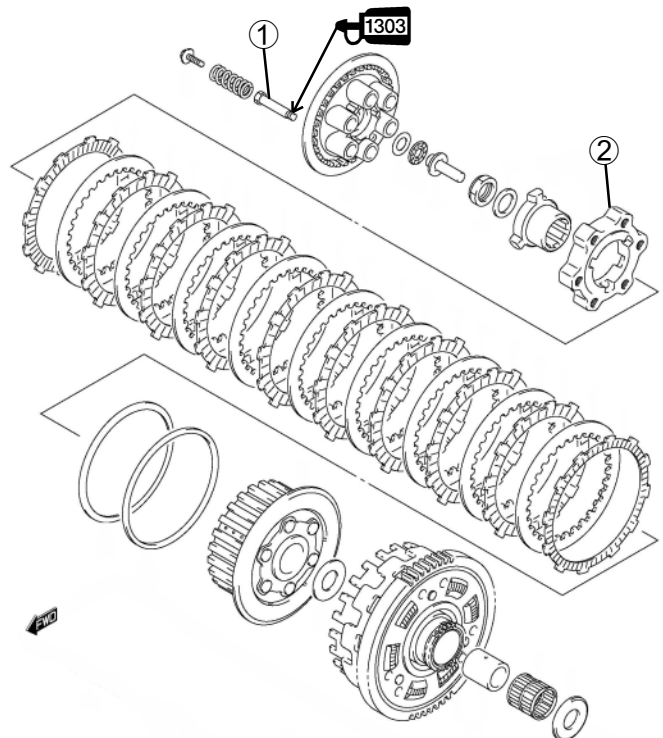
Suzuki has received field reports of a light metallic "ticking" noise coming from the clutch cover area on the right side of GSX1300RK8-K9 and GSX1300BKK8 model motorcycles. The noise is most distinguishable when the engine is running at idle speed. The noise occurs when a clutch spring support bolt ① loosens from the clutch cam ② and allows the head of a clutch spring bolt to come in contact with the clutch cover during engine operation. Typically, when found on retail units this condition occurs at lower mileages.

Clean the threads of the clutch spring support bolts ① and clutch cam ②. Apply thread lock to the clutch spring support bolts and tighten them to the specified torque. Install the clutch cover using a new gasket and tighten the cover bolts to the specified torque.

: Thread lock cement 99000-32030
(Thread Lock Cement Super 1303 or equivalent)

Clutch Spring Support Bolts 23 N·m
(2.3 kgf-m, 16.5 lb-ft)

Clutch Spring Bolts 10 N·m (1.0 kgf-m,
7.0 lb-ft)

Clutch Cover Bolts 10 N·m (1.0 kgf-m,
7.0 lb-ft)
